# Manhole Inspection Summary

Manhole # S51GG\_014MH

Insp Date: **6/9/08 8:51 AM**

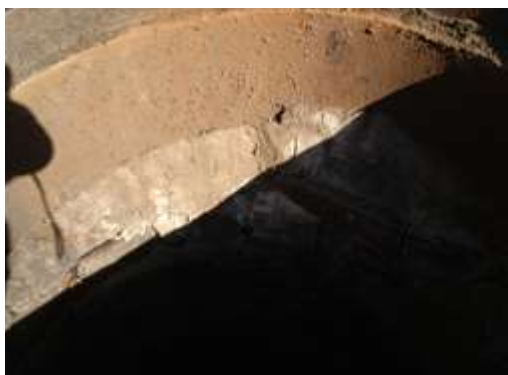
Defect 1

☒ **Loose Brick**

☒ **Deteriorated**

☒ **Mortar**

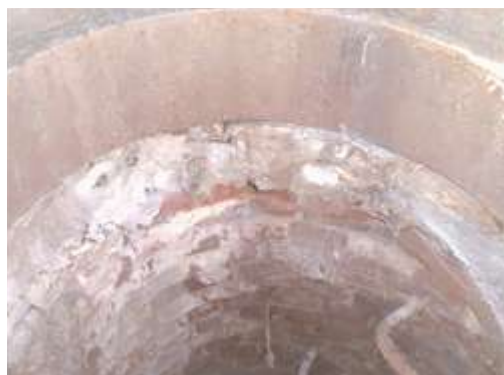
Defect 2

deterioration

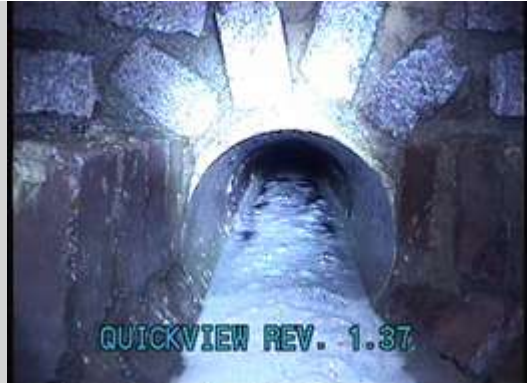
12 O'Clock Outflow

8 in. Circular Gravity Sewer  
Pipe Out @ 12 O'Clock

Pipe Height: **8.4** (in.) Rod and Bar (Angled)  
Pipe Material: **Clay** ☐ Pipe Lined  
Invert Depth: **11.95** (ft.) Flow Characteristics: **Fast**  
Deposits: ☒ None ☐ Mud ☐ Sludge ☐ Debris ☐ Grease  
Silt Depth: (in.) Deposits Extent:  
Infiltration: **None** Pipe Seal Cond: **Sound**

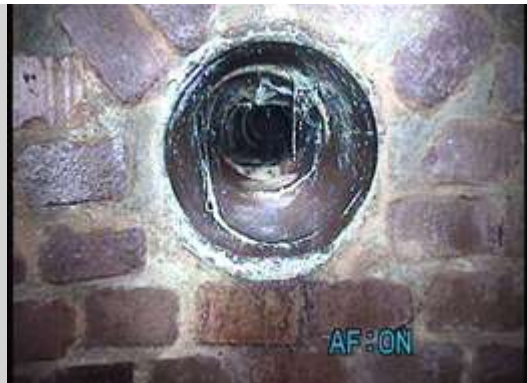
3 O'Clock Inflow

8 in. Circular Gravity Sewer  
Pipe In @ 3 O'Clock

Pipe Height: **8.4** (in.) Rod and Bar (Angled)  
Pipe Material: **Clay** ☐ Pipe Lined  
Invert Depth: **9.00** (ft.) Flow Characteristics: **Fast**  
Deposits: ☒ None ☐ Mud ☐ Sludge ☐ Debris ☐ Grease  
Silt Depth: (in.) Deposits Extent:  
Infiltration: **None** Pipe Seal Cond: **Sound**

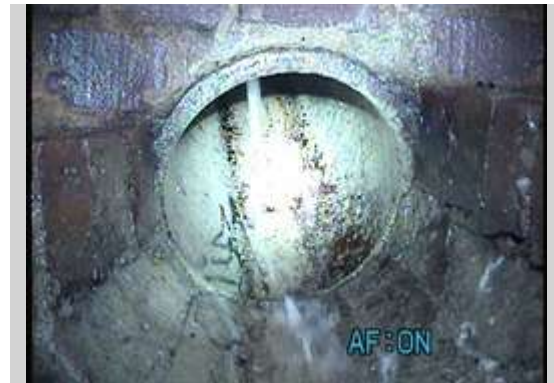
Drop In @ 3 O'Clock

Drop: **Inside** Rod and Bar  
Angled: **Yes** Reading: **10.80** (ft.)  
Inv Depth: **11.80** (ft.)  
Drop Condition: **Open**

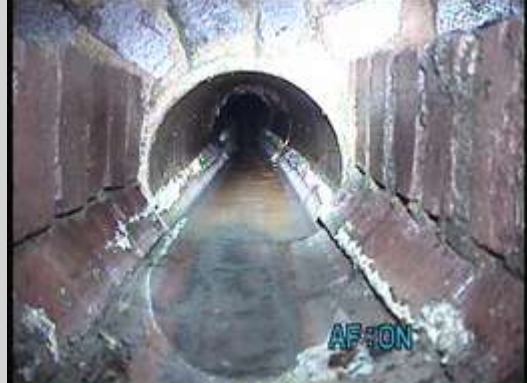
6 O'Clock Inflow

8 in. Circular Gravity Sewer

Pipe In @ 6 O'Clock

Pipe Height: **8.4** (in.) Rod and Bar (Angled)

Invert Depth: **12.05** (ft.) Flow Characteristics: **Slow**

Infiltration: **None** Pipe Seal Cond: **Sound**
